Lecture 23: Groundwater Contamination II

Key Questions

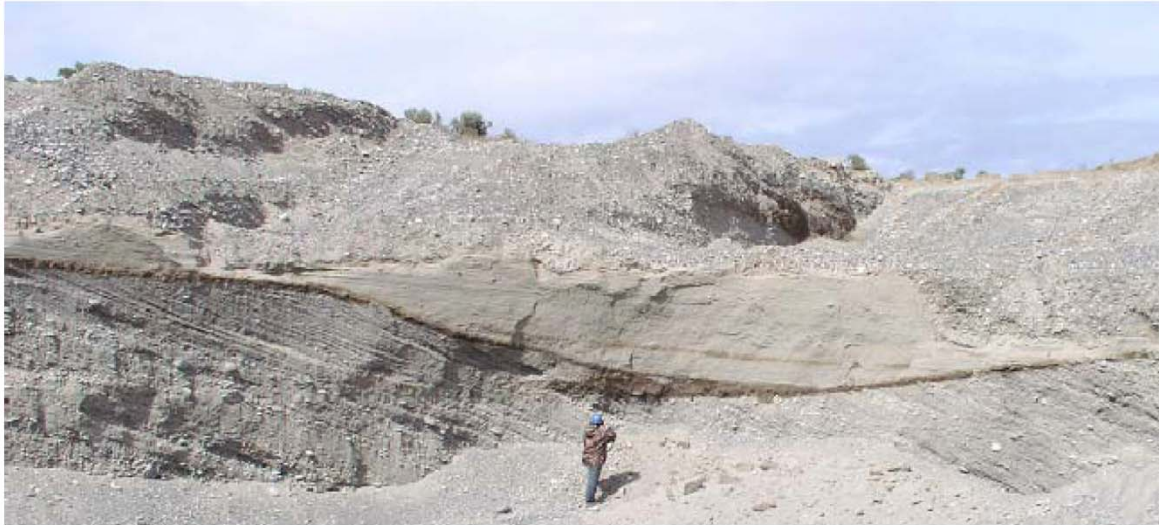
Figure C-4. Gravel-Dominated Sediments of the Hanford formation Exposed in Pit #30.

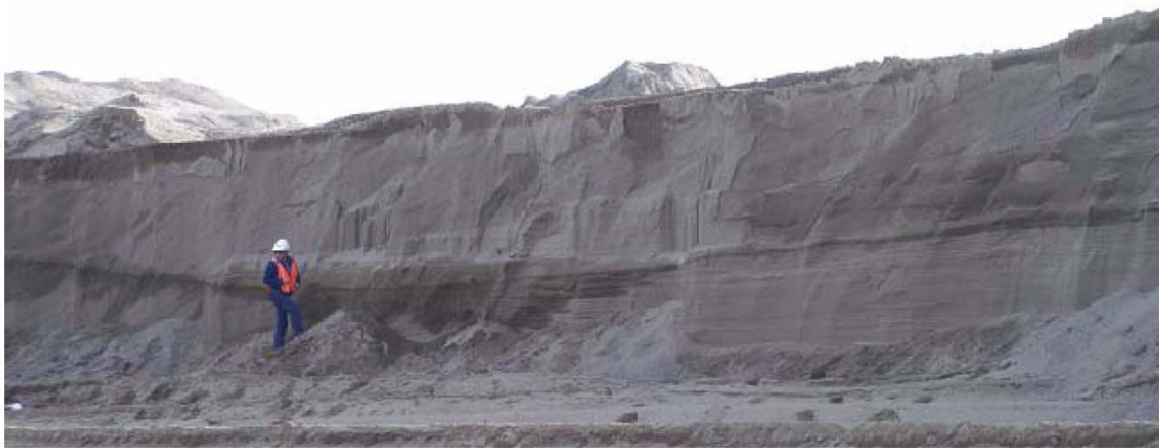
Figure C-5. Sand-Dominated Sediments of the Hanford formation Exposed at the Integrated Disposal Facility.

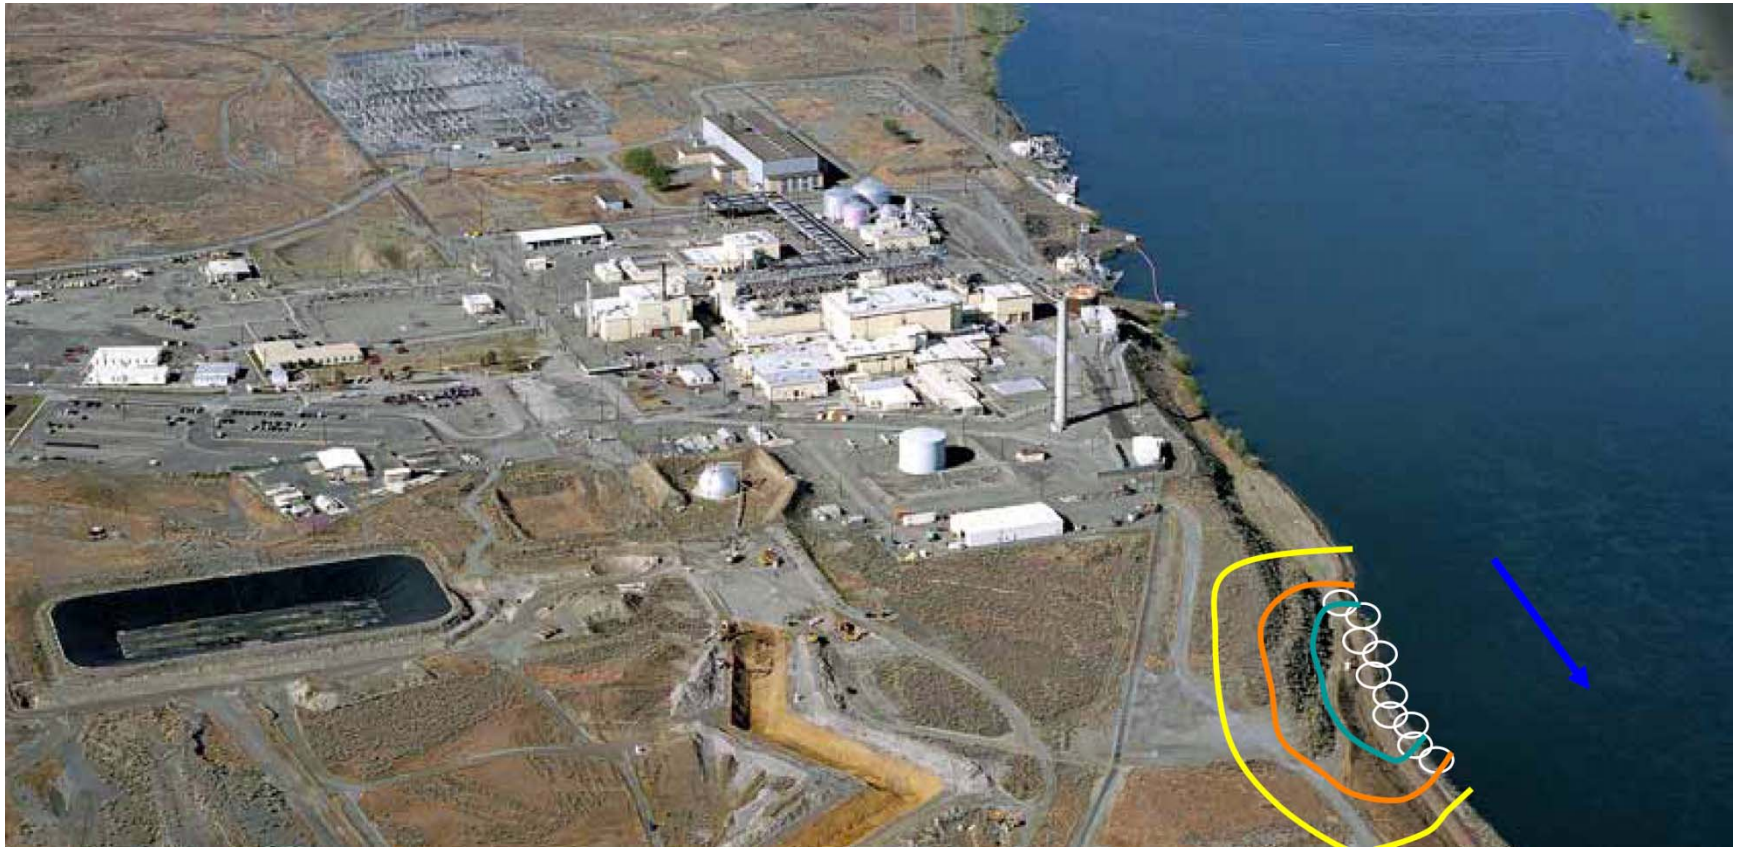
100-K Area Chromium Plume Distribution

100-K Pump & Treat Operations

Operated Since 1997

~265 Kg Removed

Observed elevated Chromium in Aquifer Tubes Near The KW Reactor Area in 2004

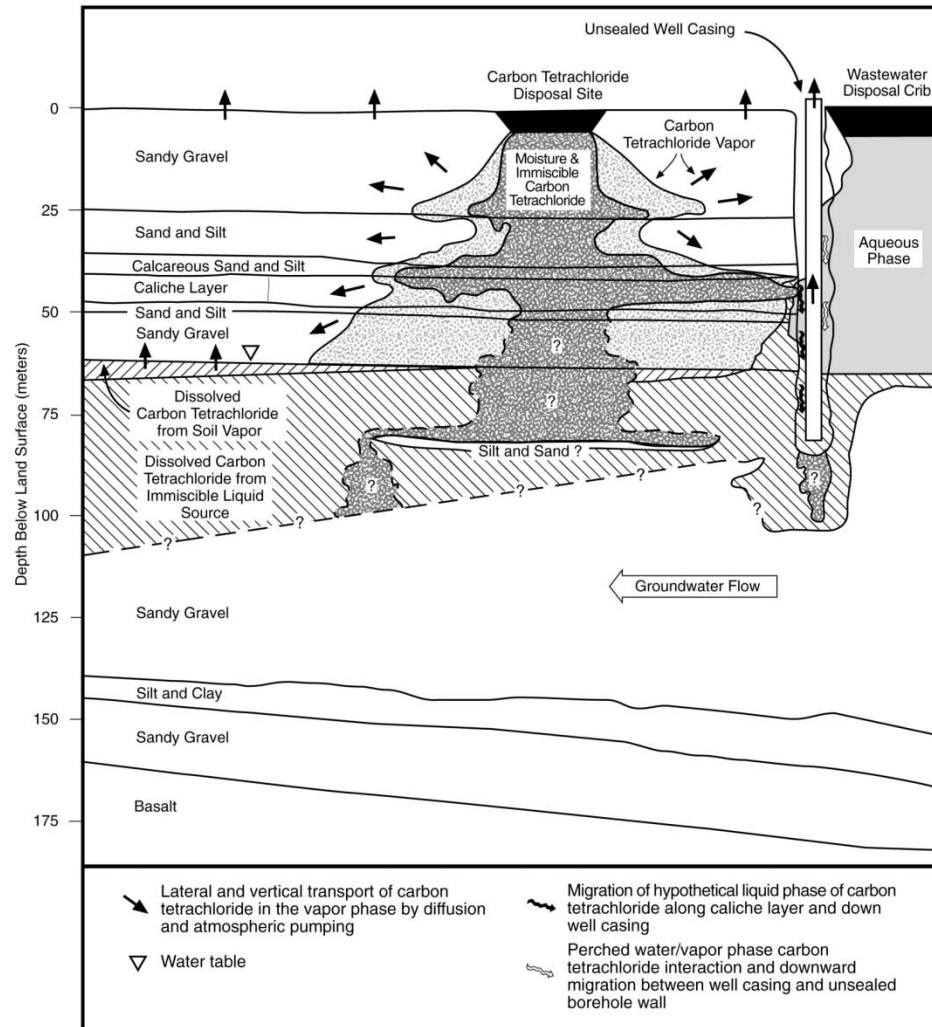
Figure C-8. Schematic of Transport Mechanisms and Distributions of Carbon Tetrachloride Phases (Rohay 1999).
